**Mapping Vulnerability of Infrastructure to Destruction by Slope Failures on  
the Island of Dominica, WI:**

**A CASE STUDY OF GRAND FOND, PETITE SOUFRIERE, AND  
MOURNE JAUNE**

A Thesis

Zachary Dean Andereck

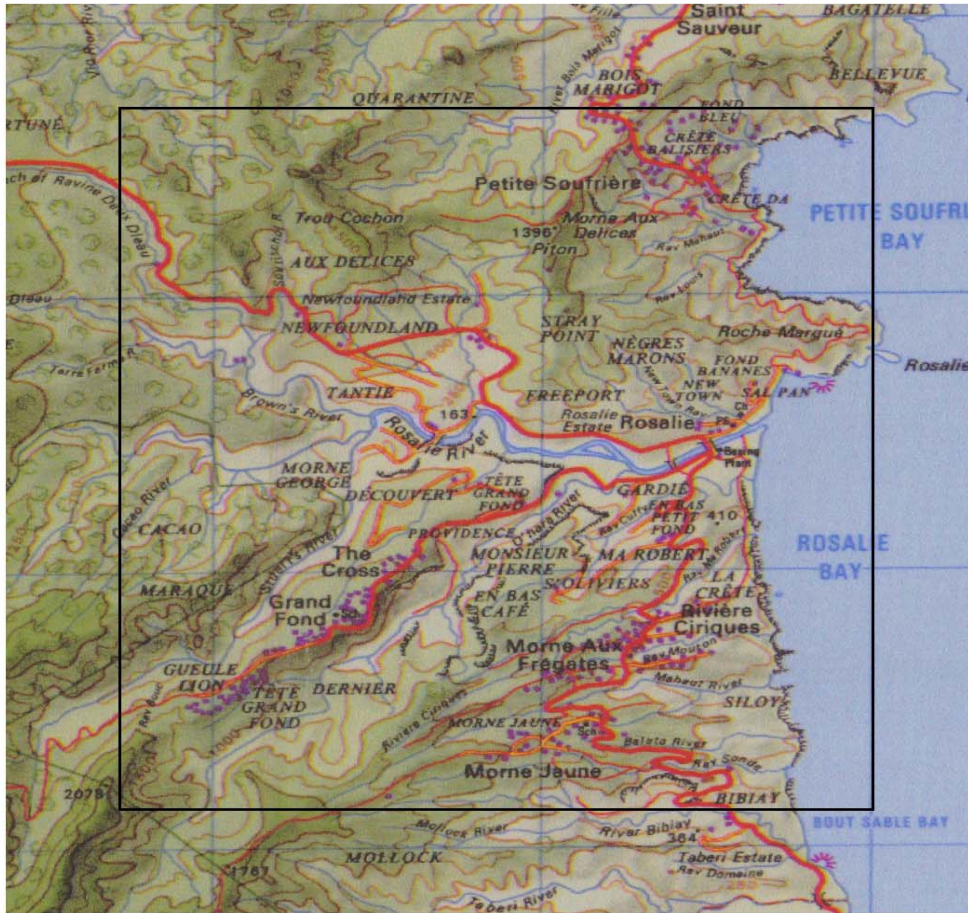
Figure 1.2  
Research area on Dominica

## Dominica Research Area

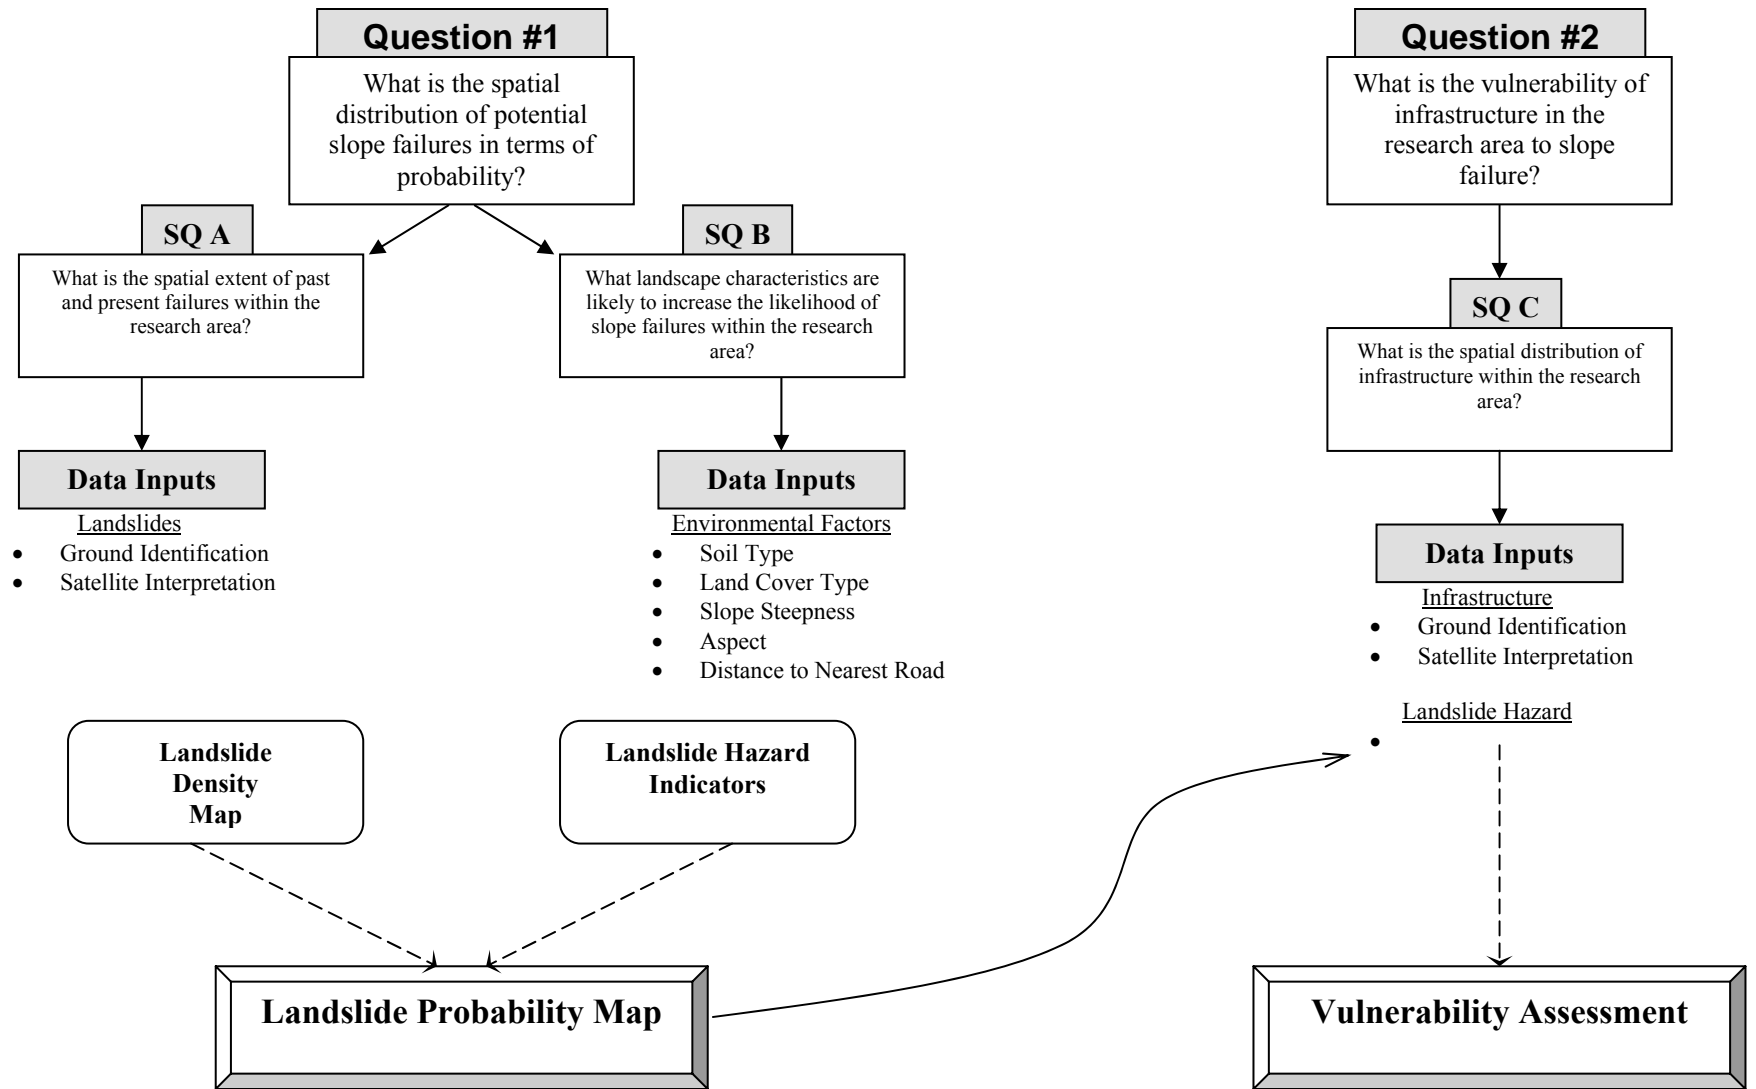
**Figure 1.3:**  
 Research framework used to investigate the spatial and vulnerability components of landslides.

This study provides an improved understanding of the spatial distribution of slope failures and the vulnerability of infrastructure to slope failures on the small Eastern Caribbean island of Dominica. Through a case study, the local communities of Grand Fond, Petite Soufriere, and Morne Jaune are examined to gauge the likelihood of slope failures and potential infrastructure at risk from slope failures. Located on the southeast coast of Dominica, these villages are susceptible to landsliding (Figure 1.2). In the event of major slope failures, these communities are vulnerable to being isolated from relief because of limited access to the villages. These villages have the potential to also experience considerable damage to infrastructure. My field work and resulting analysis is guided by the project framework (Figure 1.3).

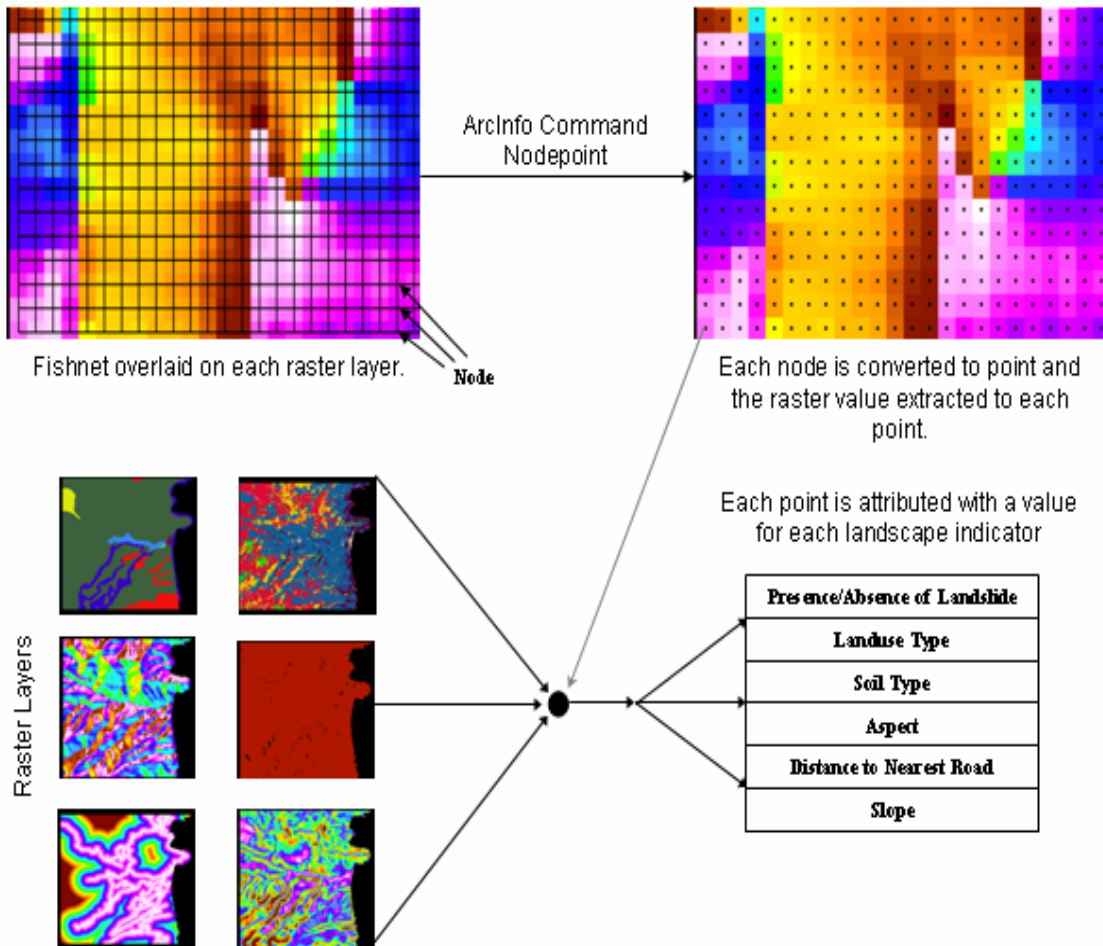
**Figure 4.1**

“Raster Core” procedure for attribution of each cell with the various landscape indicators.

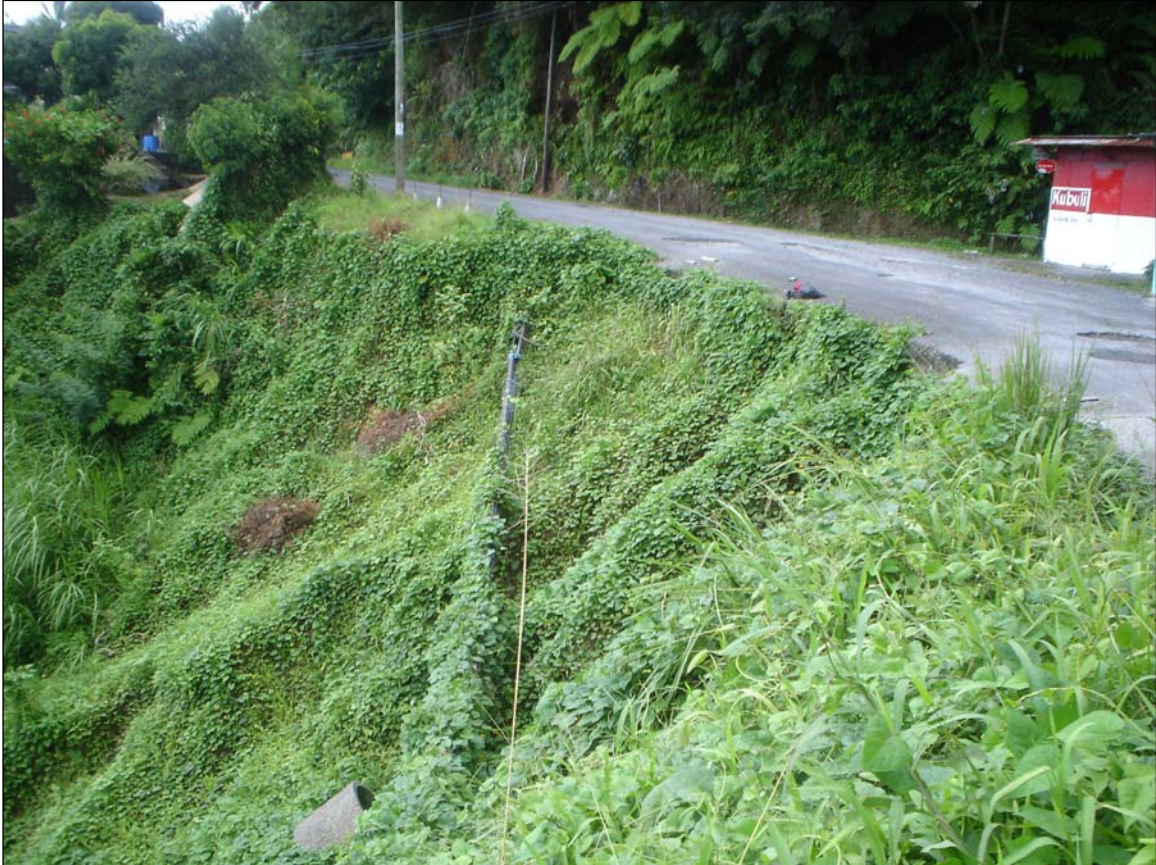
**Figure 6.2**

Landslide that has been active for several years. It has slowly eaten away at the roadway and exposed water and sewage lines, visible in the middle of the picture. In December of 2006, mitigation of this landslide was started through the installation of a retaining wall using sheet piling.

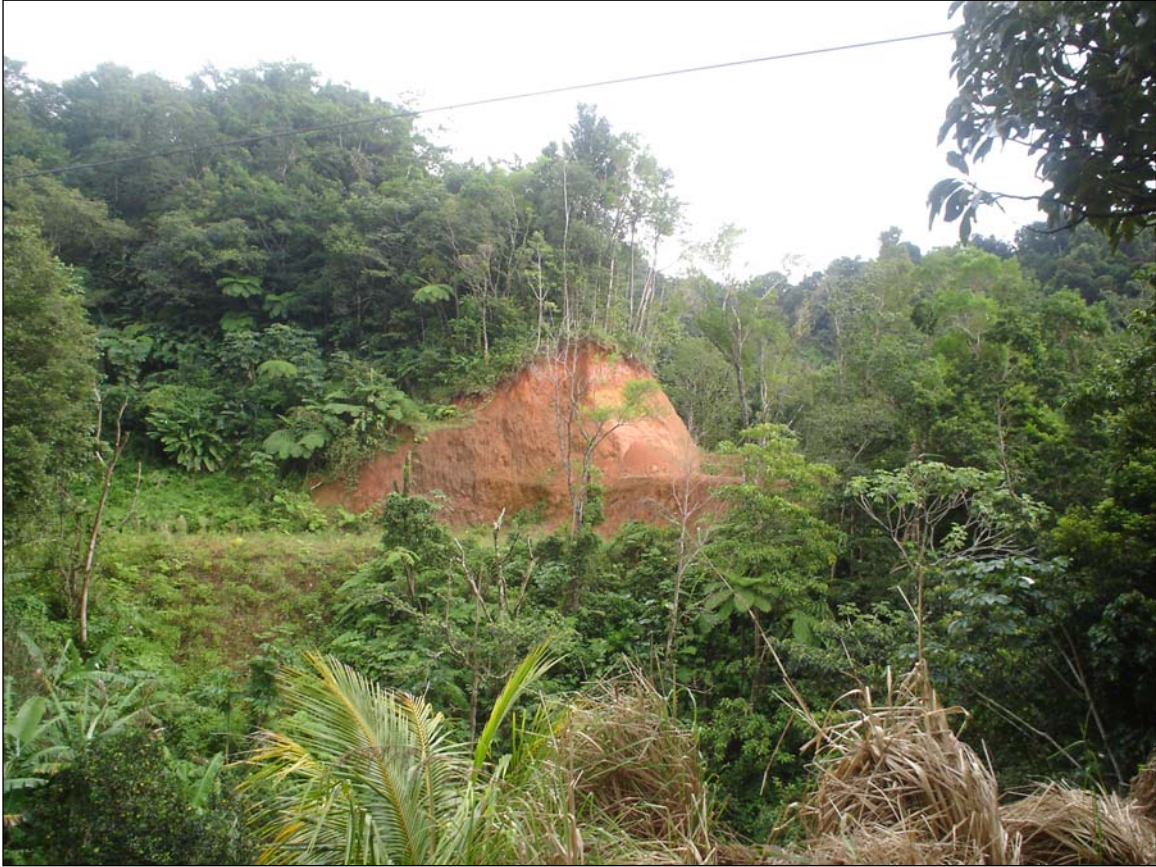
**Figure 6.3**

The site of illegal clearing near Crescent Moon Cabins that has since been the cause of significant sedimentation in the stream that runs by Crescent Moon Cabins.

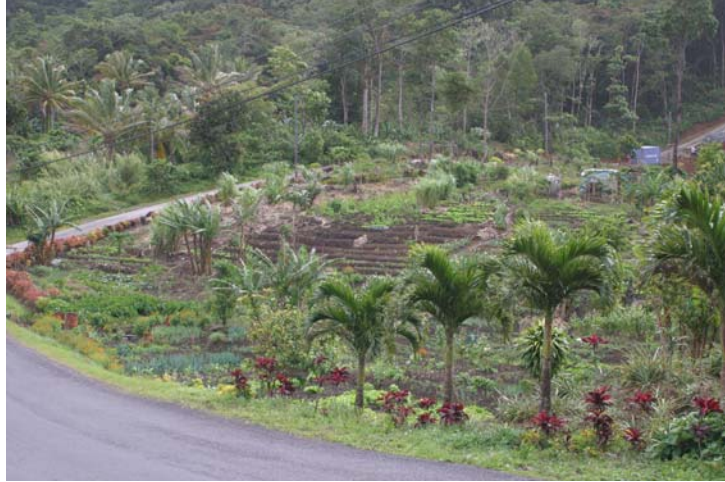
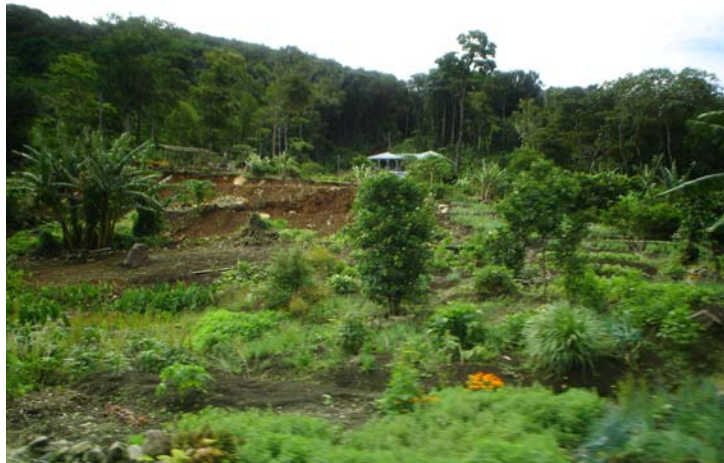
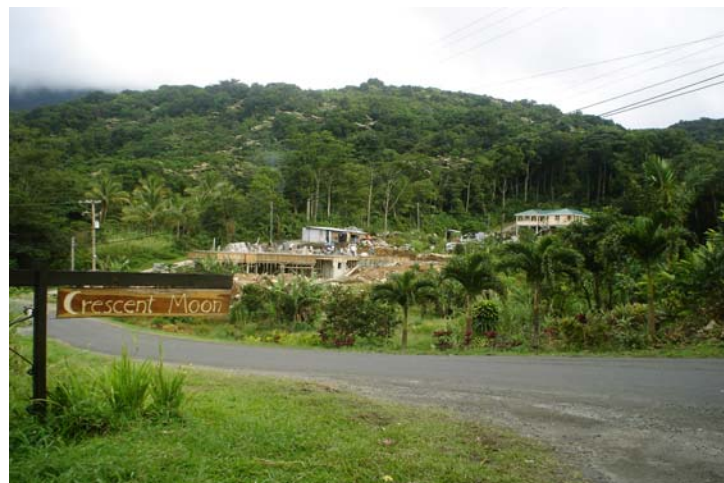
**Figure 6.4**

These three pictures are a nine month time series of an organic garden near Crescent Moon Cabins. Note the change in the upper left of each image.

Degradation of the land from development in this area is clearly evident in just nine months since the first observations were made. This means that the mindset of the people in this area have shifted and is reflected in the shift from a lifestyle in harmony with nature to one opposed, or in conflict with nature. The placing of monetary value of the land above the well being of the land, and the people linked to the land, puts these areas at a greater vulnerability to landslides and other natural hazards. This shift in values from a more holistic lifestyle to one driven by capital creates the conflict between humans and nature (White, 1967; Murphy, 1994; Oliver-Smith, 2004). This is because the people settling in these areas are not knowledgeable of the potential risks because of a lack of knowledge about the risks and degradation to the environment.
